**Our reference:** 12606359-LTR-2

**December 19, 2023**

**Mr. Sam Bennett  
Muscatine Power and Water  
3205 Cedar Street  
Muscatine, Iowa 52761**

### **2023 Landfill Inspection Letter Report**

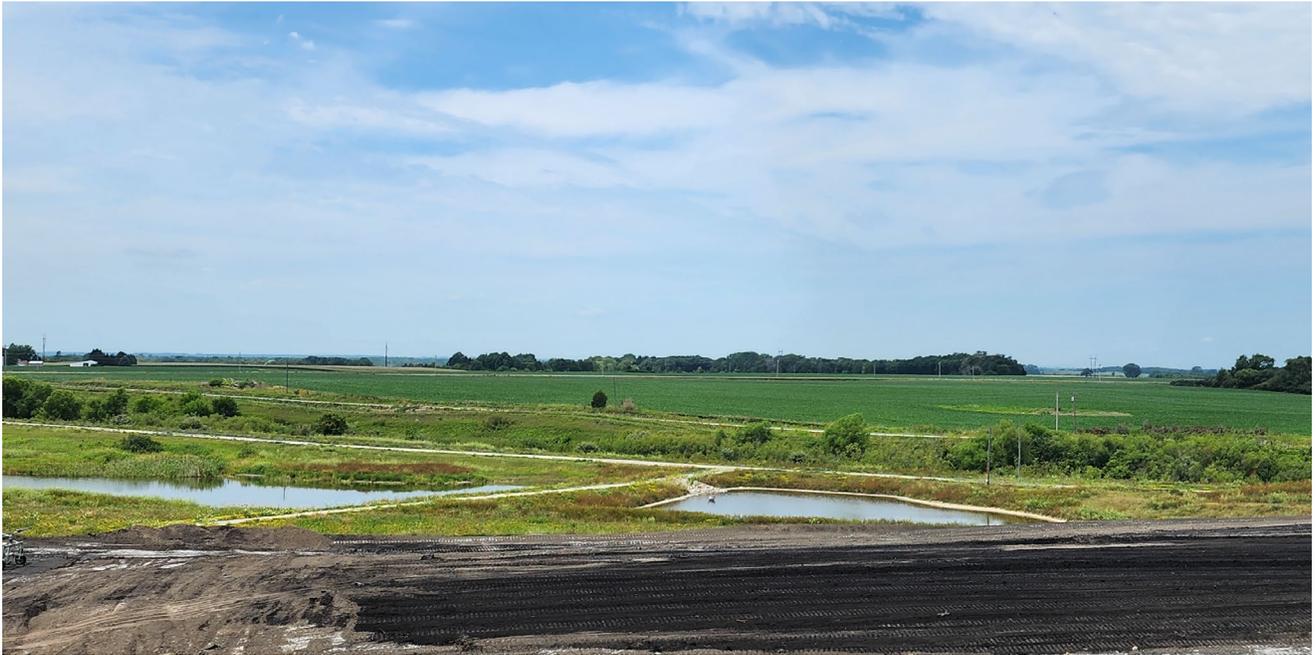
**Photo 1**      *Active fill area in foreground. Pond system in the background.*

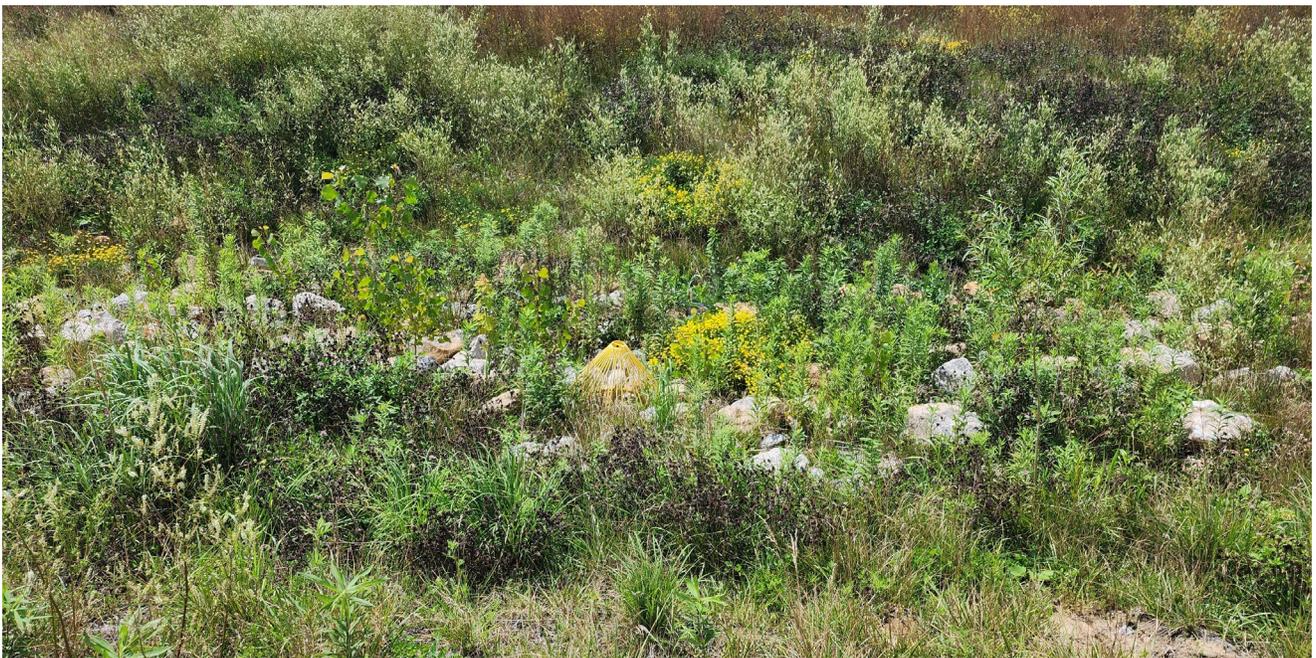
**Photo 2**      *Example rock check dam with vegetative infill.*

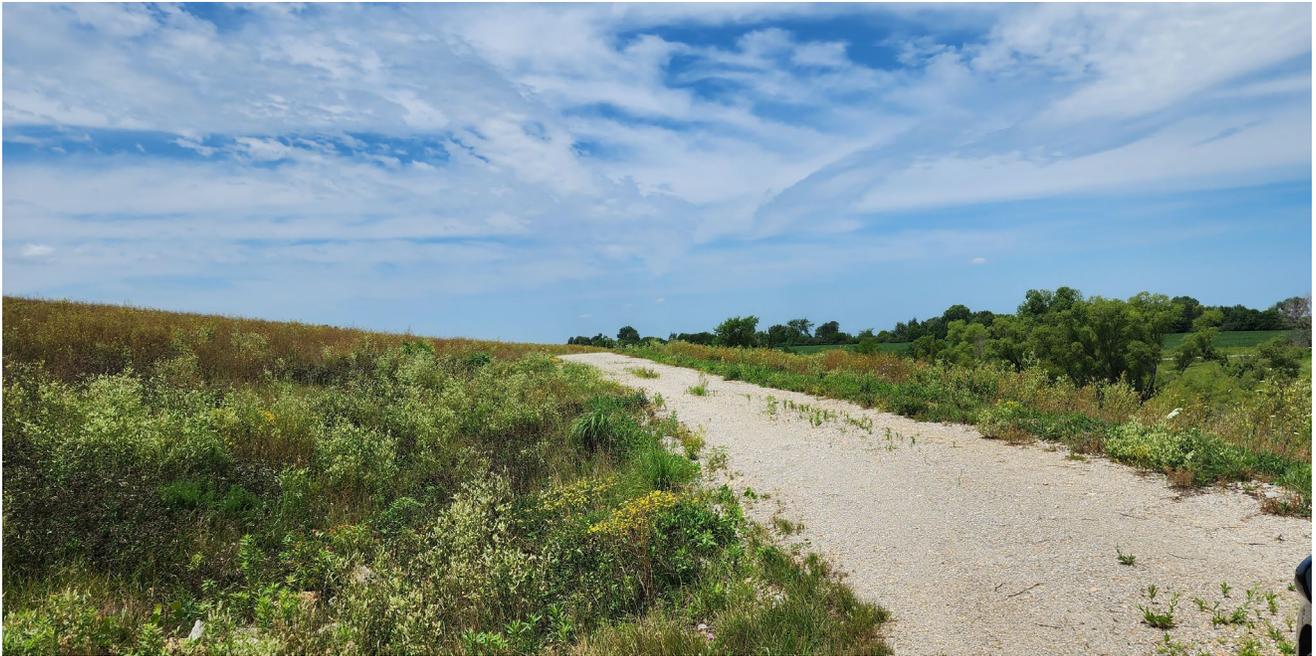
**Photo 3** *Example gravel road and final cover vegetative growth.*

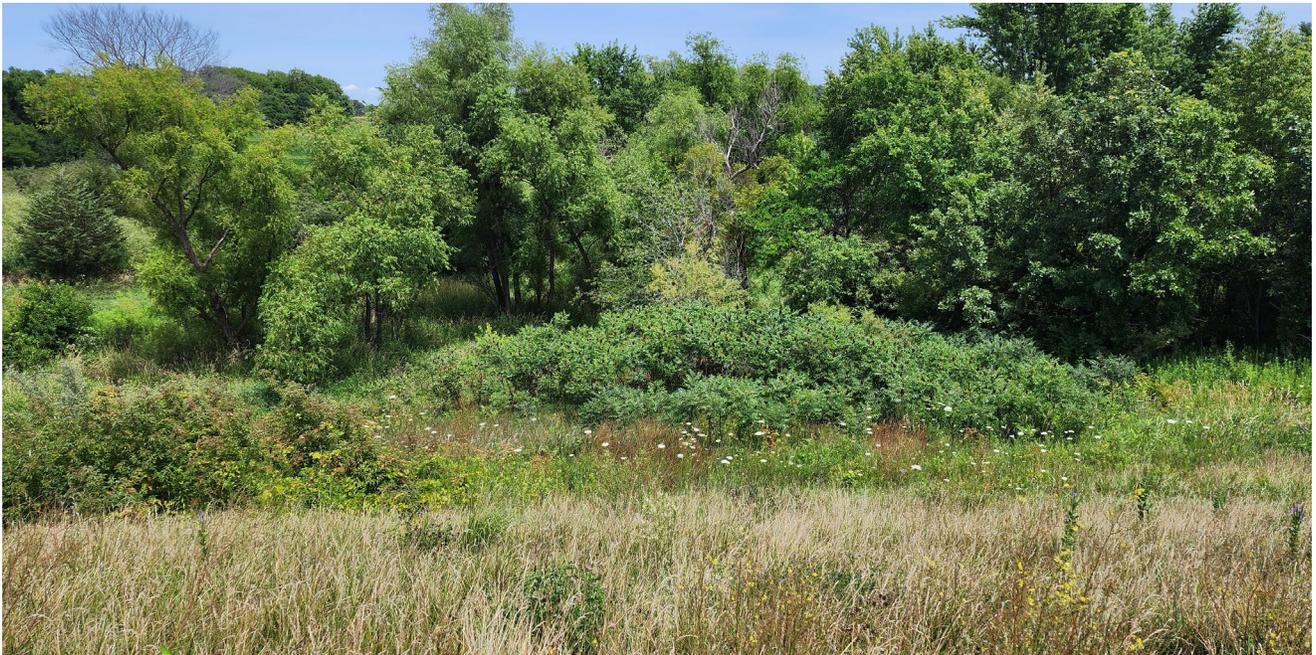
- The leachate transfer manhole appeared to have a high level of leachate and the discharge pump was not functional. MPW personnel indicated maintenance personnel would be assigned to address the pumping situation.
- There was encroaching woody vegetation on the north-northeast portions of the landfill cover. The woody vegetation should be cut back to allow regular mowing. The root systems of woody vegetation can compromise cap integrity. Regular mowing will limit the potential growth of woody vegetation.

**Photo 4** *Example woody vegetation encroaching up slope. Photograph is near stormwater bypass conveyance.*

On capped areas, it appeared the vegetation was fairly tall which gives the opportunity for woody vegetation to grow and potentially obscure hazards such as rip rap protection. A general recommendation is to increase the mowing frequency.
