Our reference: 12606359-LTR-5

Mr. Sam Bennett
Muscatine Power and Water
3205 Cedar Street
Muscatine, Iowa 52761

2024 Landfill Inspection Letter Report

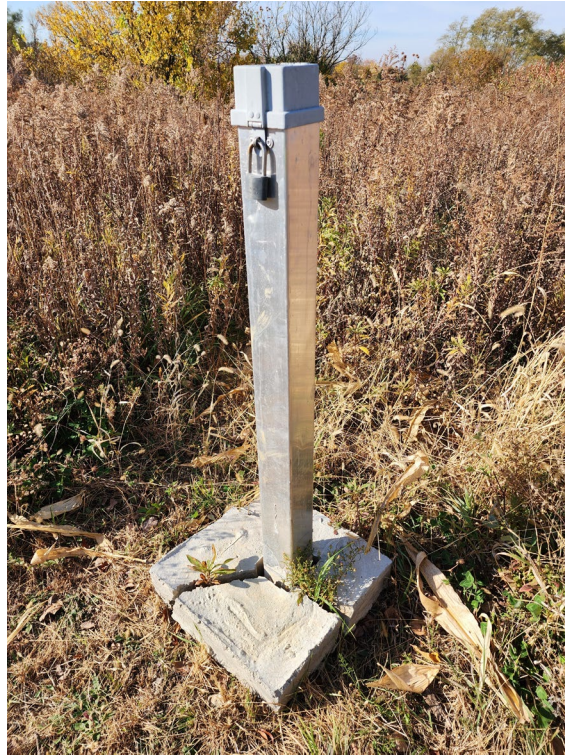
Photo 1 *Broken concrete pad at monitoring well MW-26.*

- Vegetation encroachment by woody vegetation at the north-northwest area of the closed portion of the landfill and along some drainage ways was noted. The woody vegetation should be removed.
- Well pads for monitoring wells MW-26 and MW-27 are in poor, cracked condition and should be replaced.

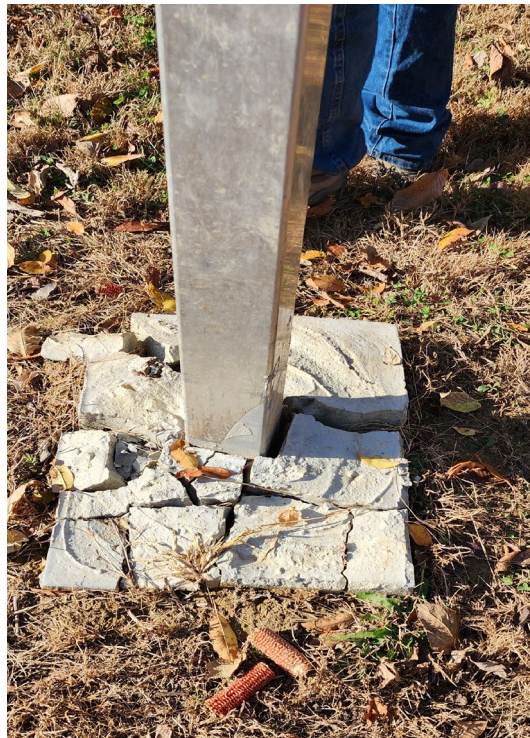
Photo 2 *Broken concrete pad at monitoring well MW-27.*

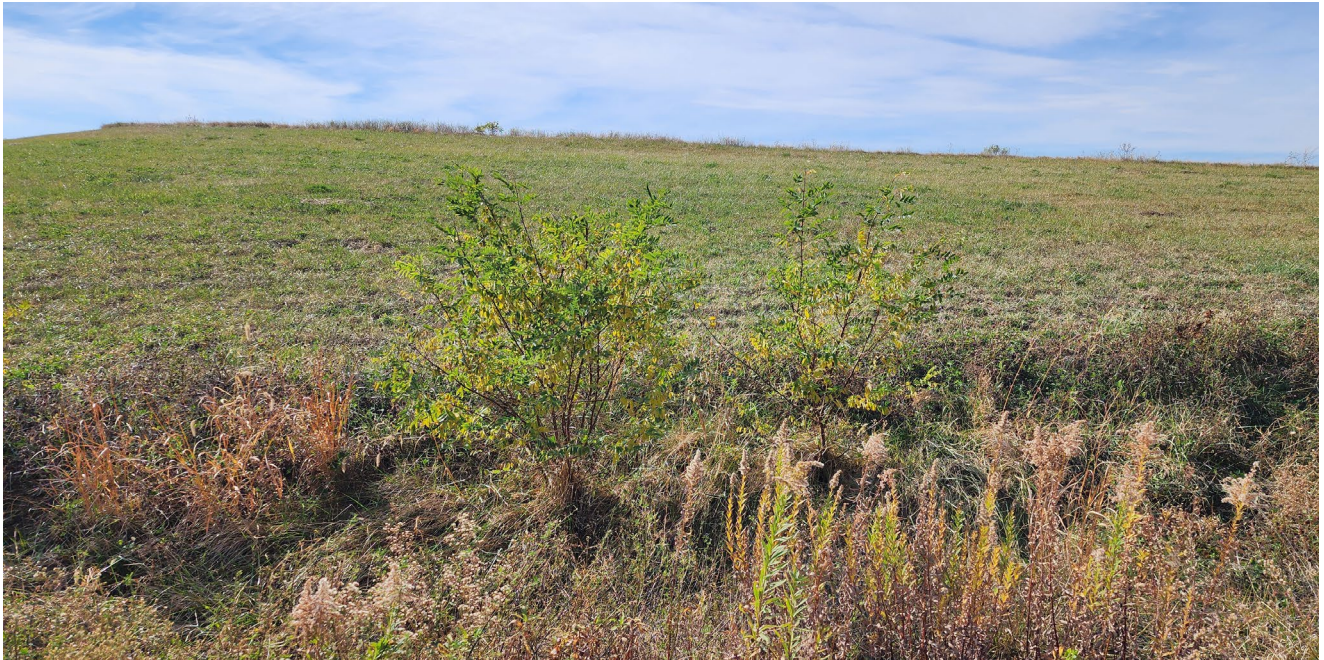
Photo 3 Example of woody vegetation growing along perimeter drainage channel and mowed final cover.

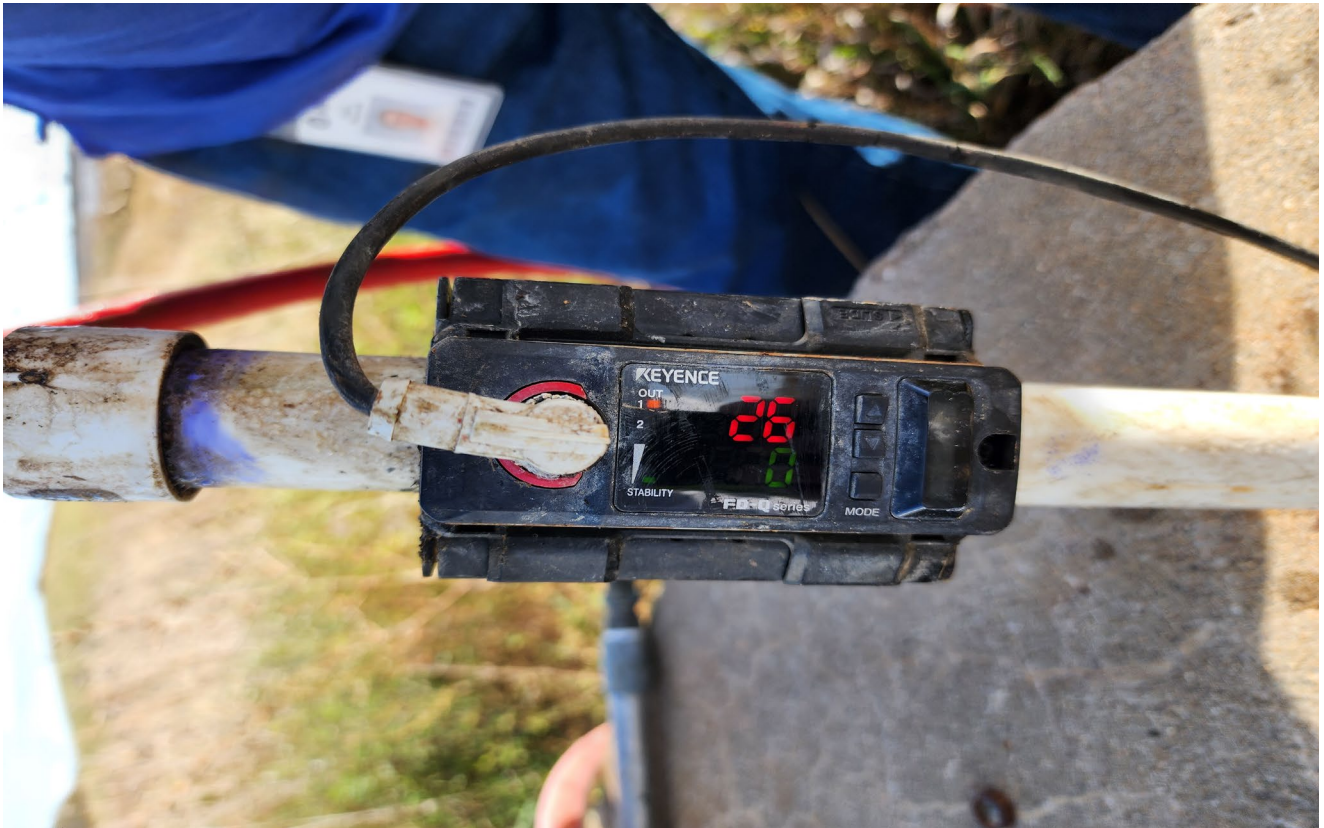
Photo 4 Leachate discharge totalizing flowmeter reading 260,000 gallons.

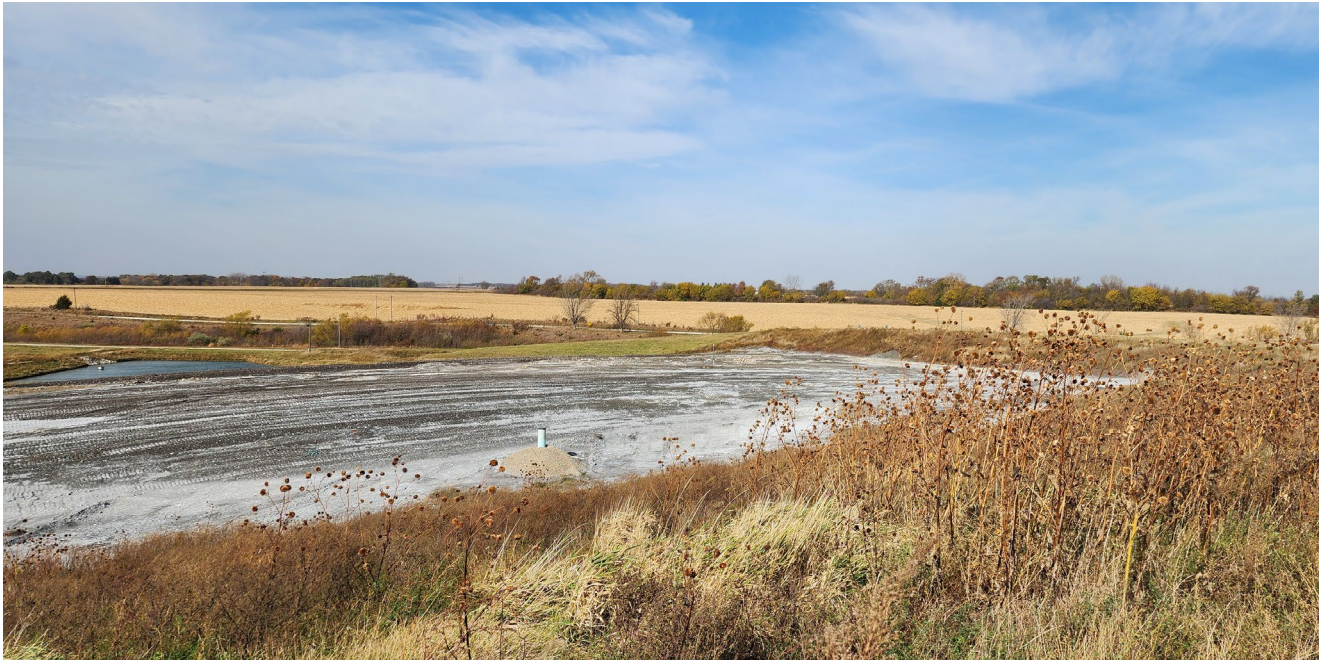
Photo 5 *Active fill area looking west from access road.*

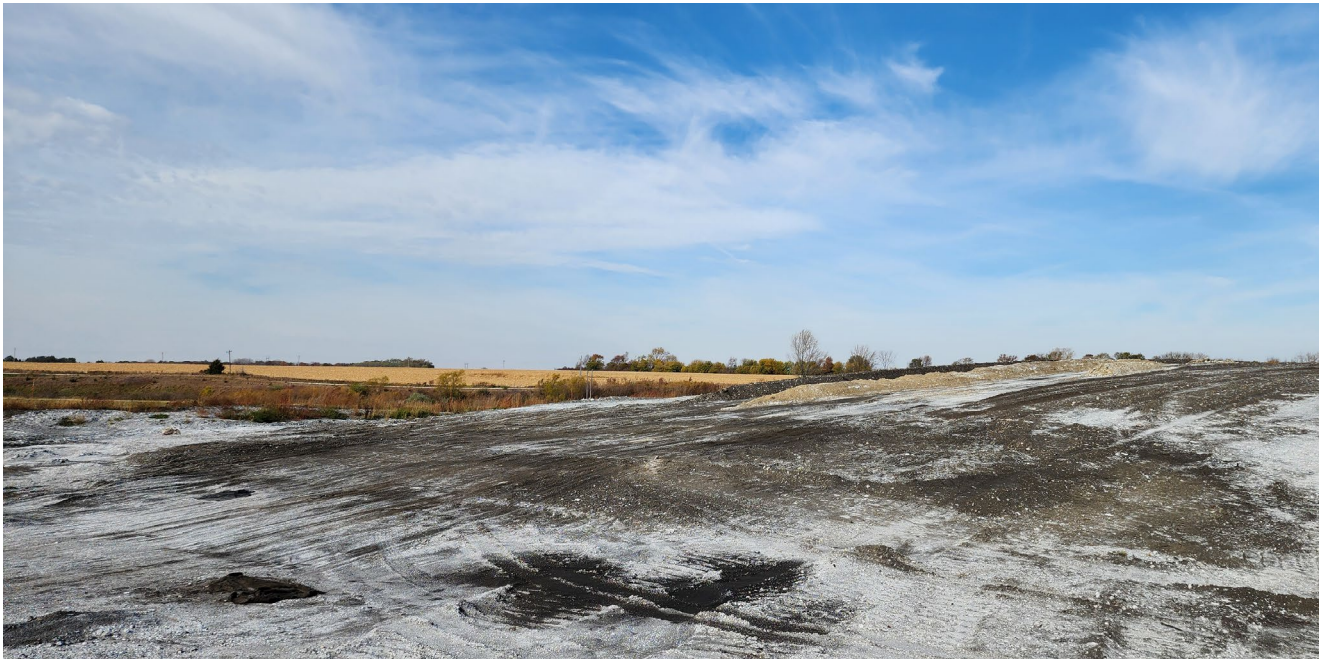
Photo 6 *Active fill area showing compacted CCR and ridge of recently deposited CCR.*
