Our reference: 12606359-LTR-9

**Mr. Sam Bennett
Muscatine Power and Water
3205 Cedar Street
Muscatine, Iowa 52761**

2025 Landfill Inspection Letter Report

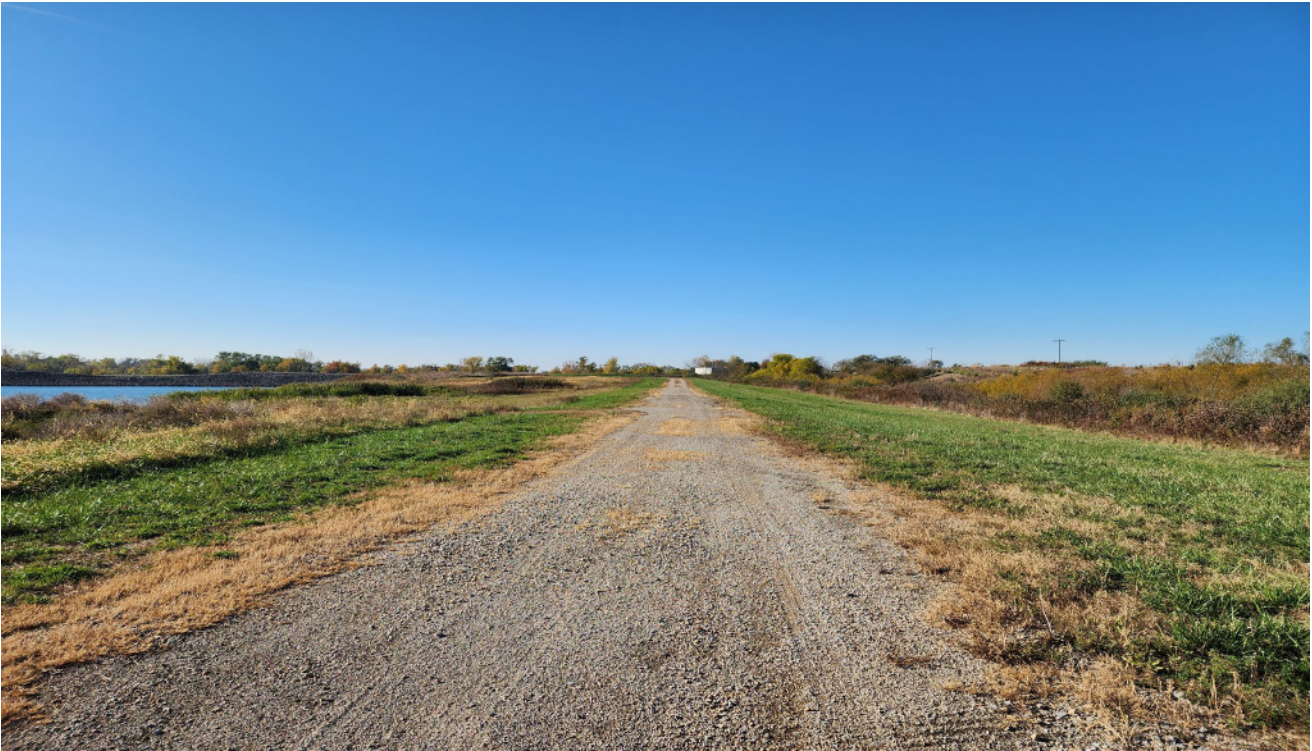
Photo 1 *Typical perimeter gravel road on west side of landfill area. Looking south.*

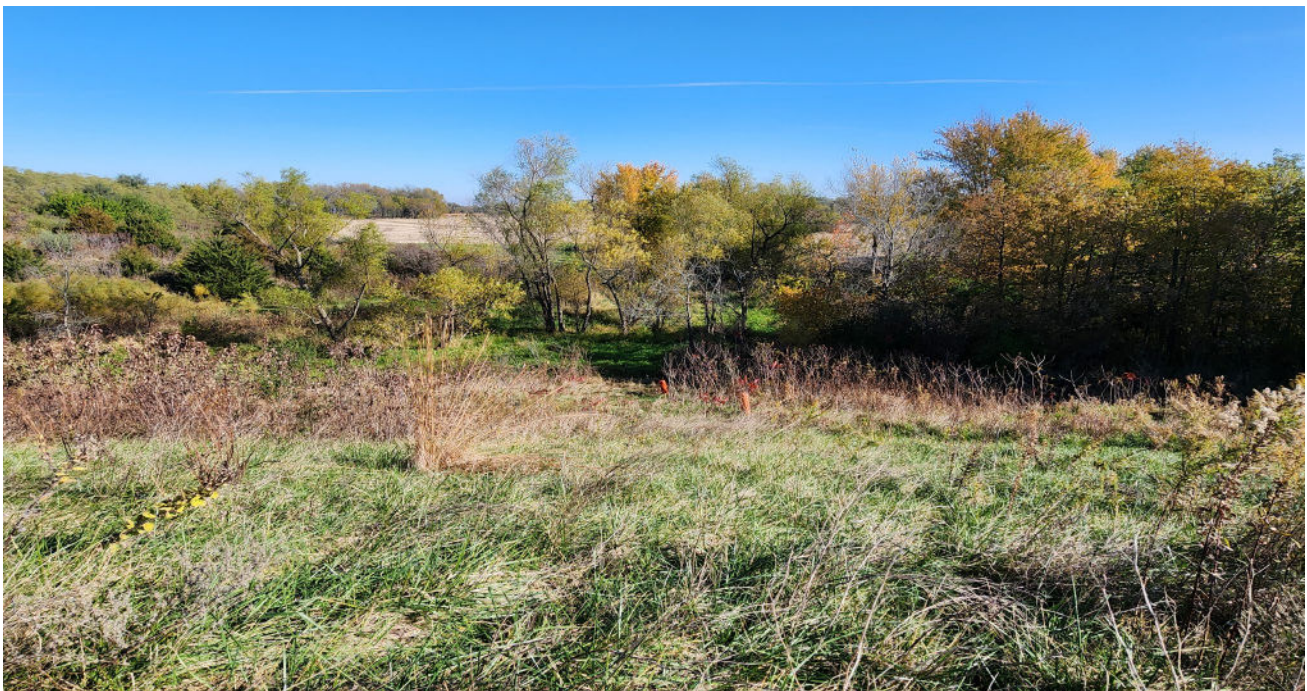
Photo 2 *Northeast side of landfill, view toward MW-10, MW-11, and MW-12. Looking northeast.*

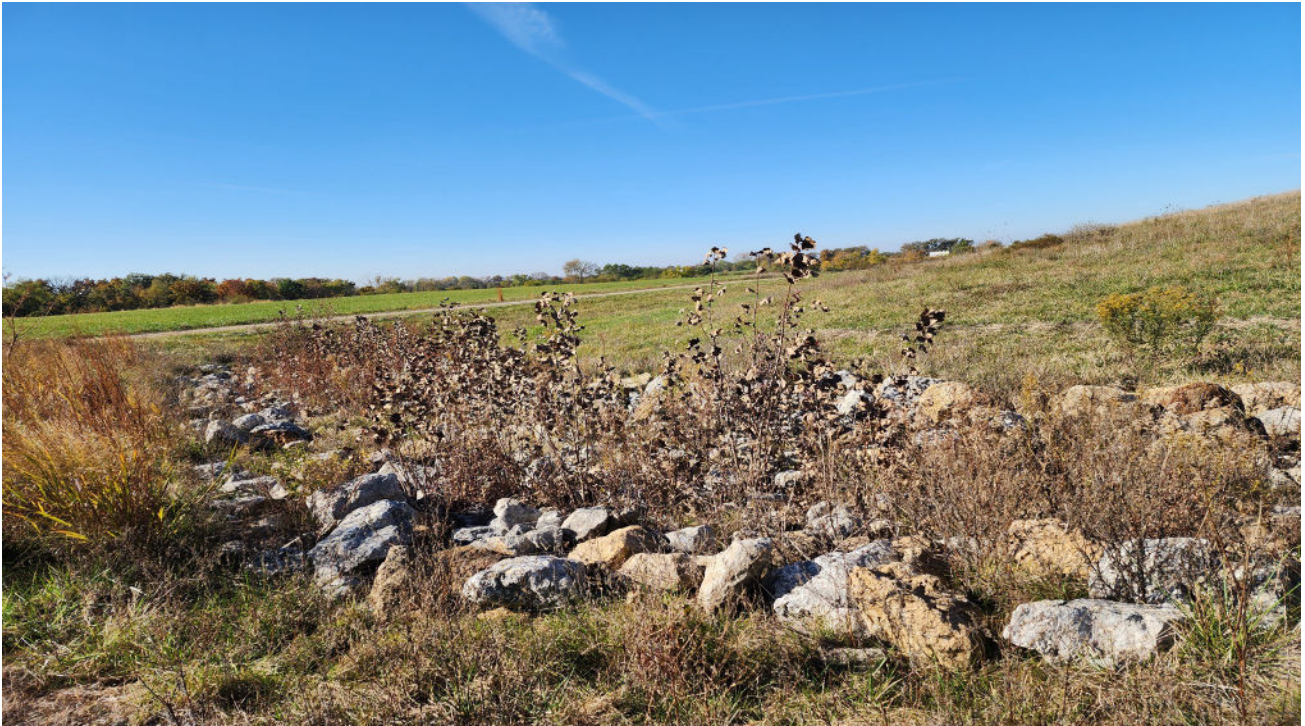
Photo 3 *Rip-rap drainage collection area at southeast corner of landfill with vegetation growth. Looking southwest.*

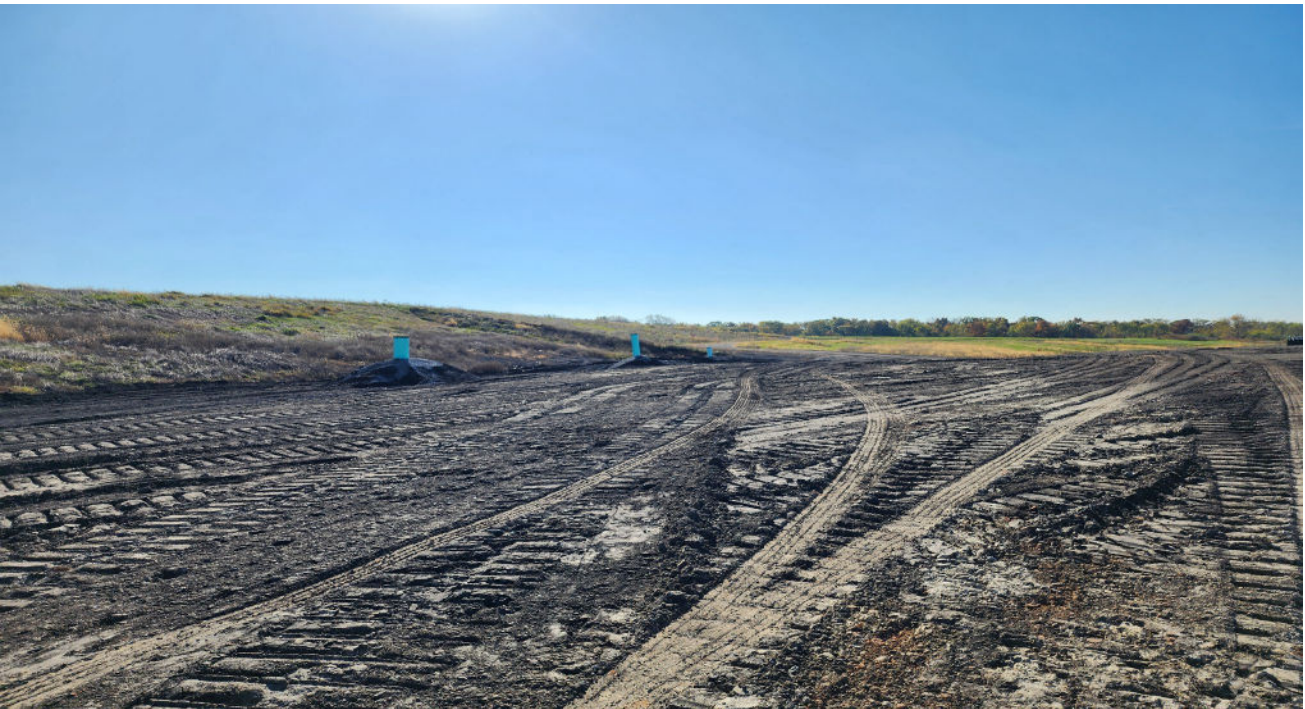
Photo 4 *Active filling area with stormwater management structures to the left. Looking south.*

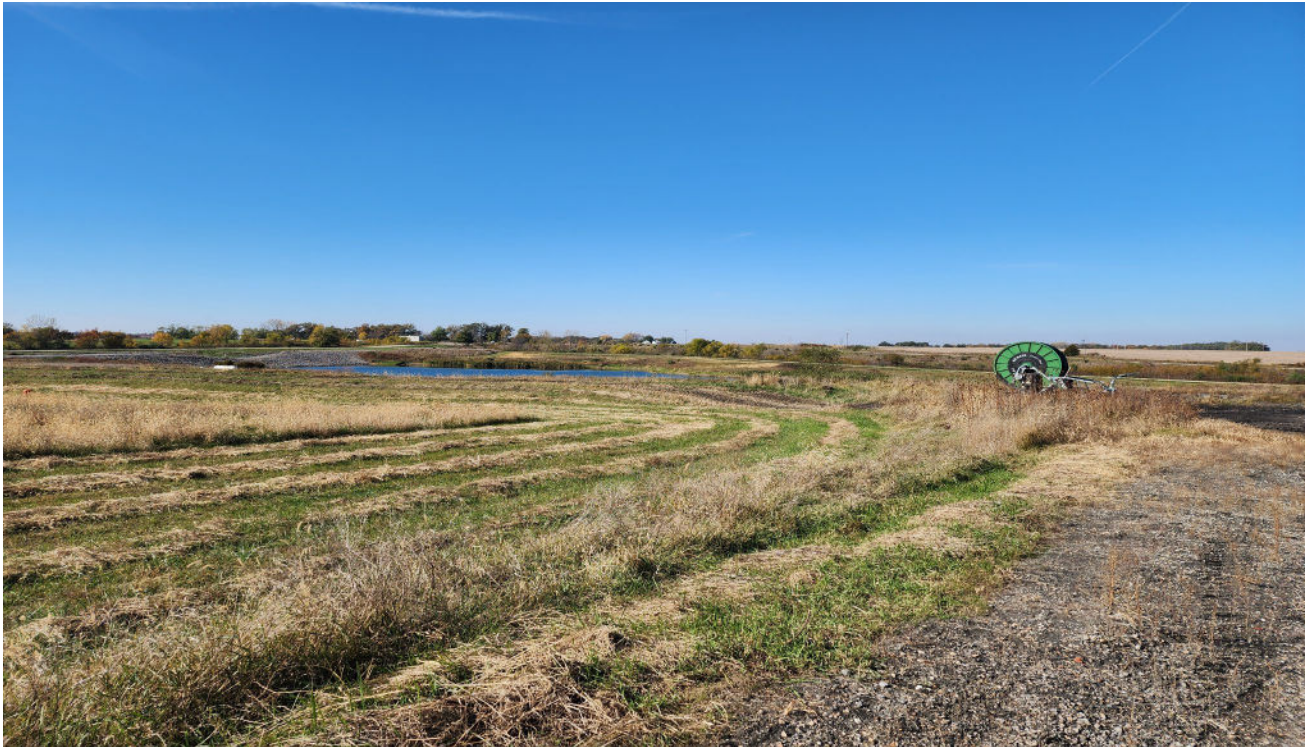
Photo 5 South end of active filling area (right) and interim-covered area (left). The green equipment is an irrigation sprinkler. Looking west.

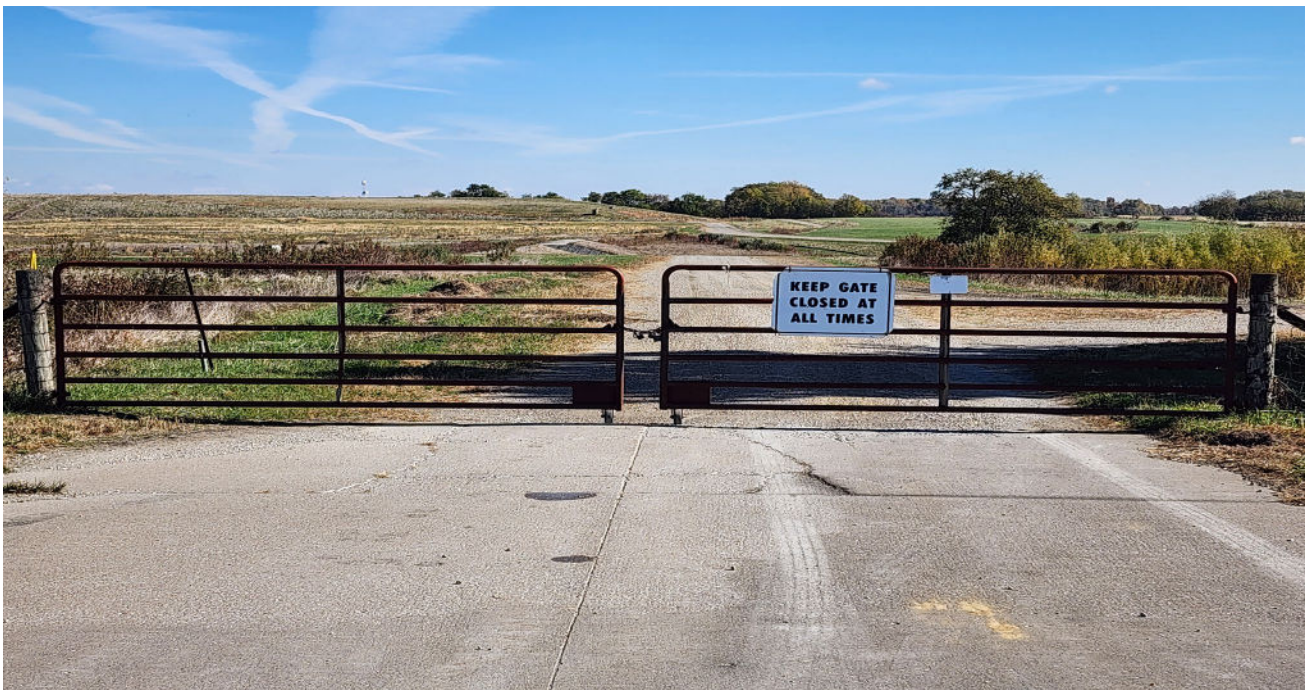
Photo 6 Typical locked entrance gate condition. Looking east.
